# Structural Health Monitoring of the Basilica S. Maria di Collemaggio

**ABSTRACT:** The work deals with the main findings obtained during the development of a permanent structural health monitoring system for a monumental church, the Basilica S. Maria di Collemaggio, strongly damaged by the 2009 L'Aquila earthquake. Ongoing studies on the causes of the partial collapse occurred in the transept area have accompanied the monitoring system design and field testing. Benefits and critical issues related with the use of the wireless sensor networks technology are analyzed in the specific case of monumental buildings monitoring. The specific features of the implemented system, purposely designed to detect low-amplitude earthquake-induced vibrations, are discussed. The information collected during one-year data acquisition is summarized, together with critical observations on the operating system. The modal signature extracted from the acceleration measurements has been compared with finite element models, furnishing valuable results to evaluate the effectiveness of the temporary scaffolding structures. Finally, specific features concerning a secondary wireless network of crack propagati

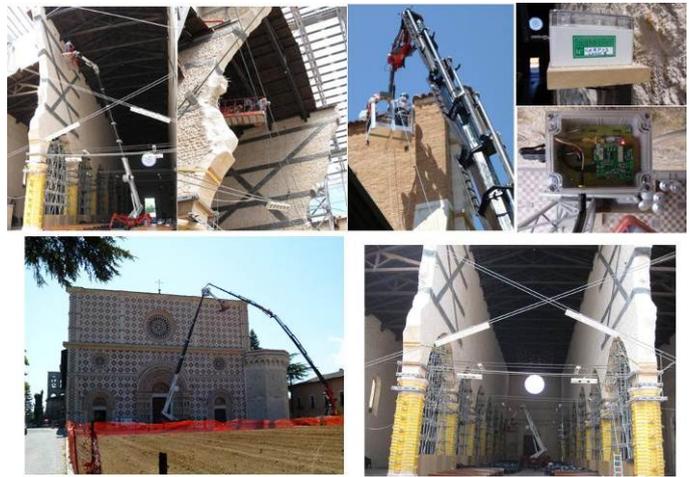
Figure 2. Installation phases of the monitoring system: a) b) sensor positioning on the central walls of the nave, c) sensor positioning beyond the facade, d) f) sensor views, g) on-site testing, h) sensor positioning at the end of the nave walls.

A total of 16 sensor nodes, conveniently installed in custom IP-45 compliant packages, were deployed along the church on June 2011.

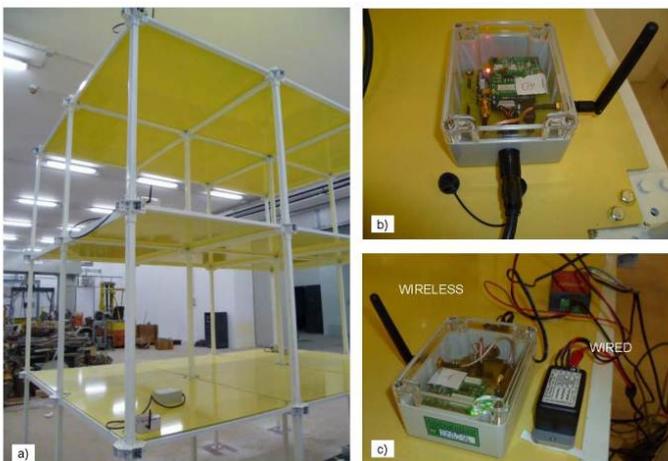
Figure 3. Light model (scale 1:3) of modular steel-made 3D frame: (a) basic configuration, (b) sensor-node of wireless network; (c) comparison with sensor of traditional wired network

The analysis of the data collected by the monitoring system has been anticipated by a preliminary phase, devoted to compare the performance of each single wireless node with a reference wired sensor in a controlled laboratory environment (Fig.3).

Two different types of test have been conducted using a modular structural steel frame to characterize a SHM-WSN in a laboratory environment. In the first series a direct comparison between a single wireless sensor (the above described IMOTE 2 type) and a wired accelerometer (SA107LN-Columbia) has been conducted (Fig. 3). With this configuration the frame responses both to a little impulse in longitudinal direction and under environmental noise have been recorded. Others tests have been made using six wireless sensors, two for each slab, placed at diagonally opposite corners. This particular experimental setup has been used to identify the main modal frequencies, shapes and damping. Again both impulsive and ambient tests have been performed. The results, here not reported for sake of brevity, were largely satisfying to the project purposes.
