Long-Term Wireless Structural Health Monitoring of the Ferriby Road Bridge

Neil A. Hoult¹; Paul R. A. Fidler²; Peter G. Hill³; and Campbell R. Middleton⁴

DOI: 10.1061/(ASCE)BE.1943-5592.0000049

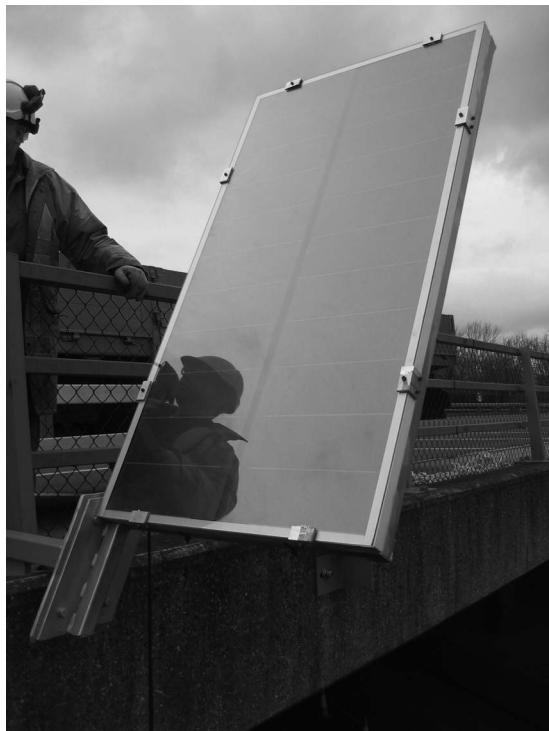
Fig. 5. Solar panel

The gateway, along with the HSDPA modem, node 7 and the 12 V battery were placed in a polycarbonate box. This box was then mounted on a bespoke steel shelf that was attached using drilled concrete anchors near the top of the eastern-most column on the south side of Ferriby Road. Wires were run between the gateway box and the solar panel which was mounted on a custom-made steel frame on the east side of the bridge facing south. The angle of the solar panel (64° to the horizontal) was chosen to optimize the amount of solar power generated by the panel over the course of a year, especially during the winter months (Hui 2002).
